Manhole Inspection Summary

Manhole # S33UU_005MH

Insp Date: **4/13/07 10:29 AM**

Location Address: **2752 MARYLAND AVE**

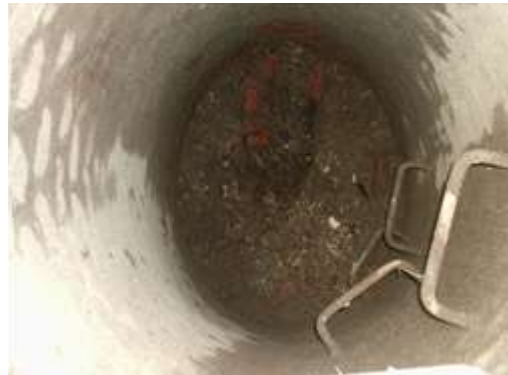
Top View

Channel debris.

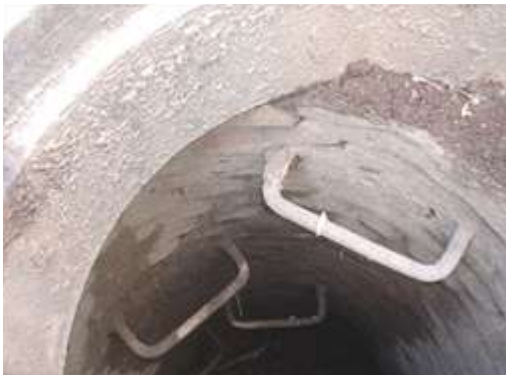
Defect

Frame leaks. Frame offset. Adjustment, Corbel and Barrel infiltration - other side.

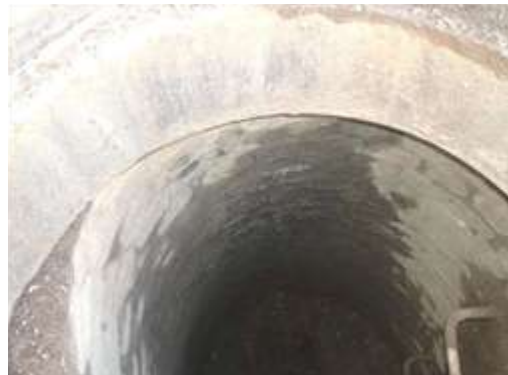
Defect

Frame leaks. Frame offset. Adjustment, Corbel and Barrel infiltration.
